Whitby Coastal Flood Risk Assessment and Municipal Class Environmental Assessment APRIL 2021

Re: Technical Report for Whitby Coastal Flood Hazard Risk Assessment

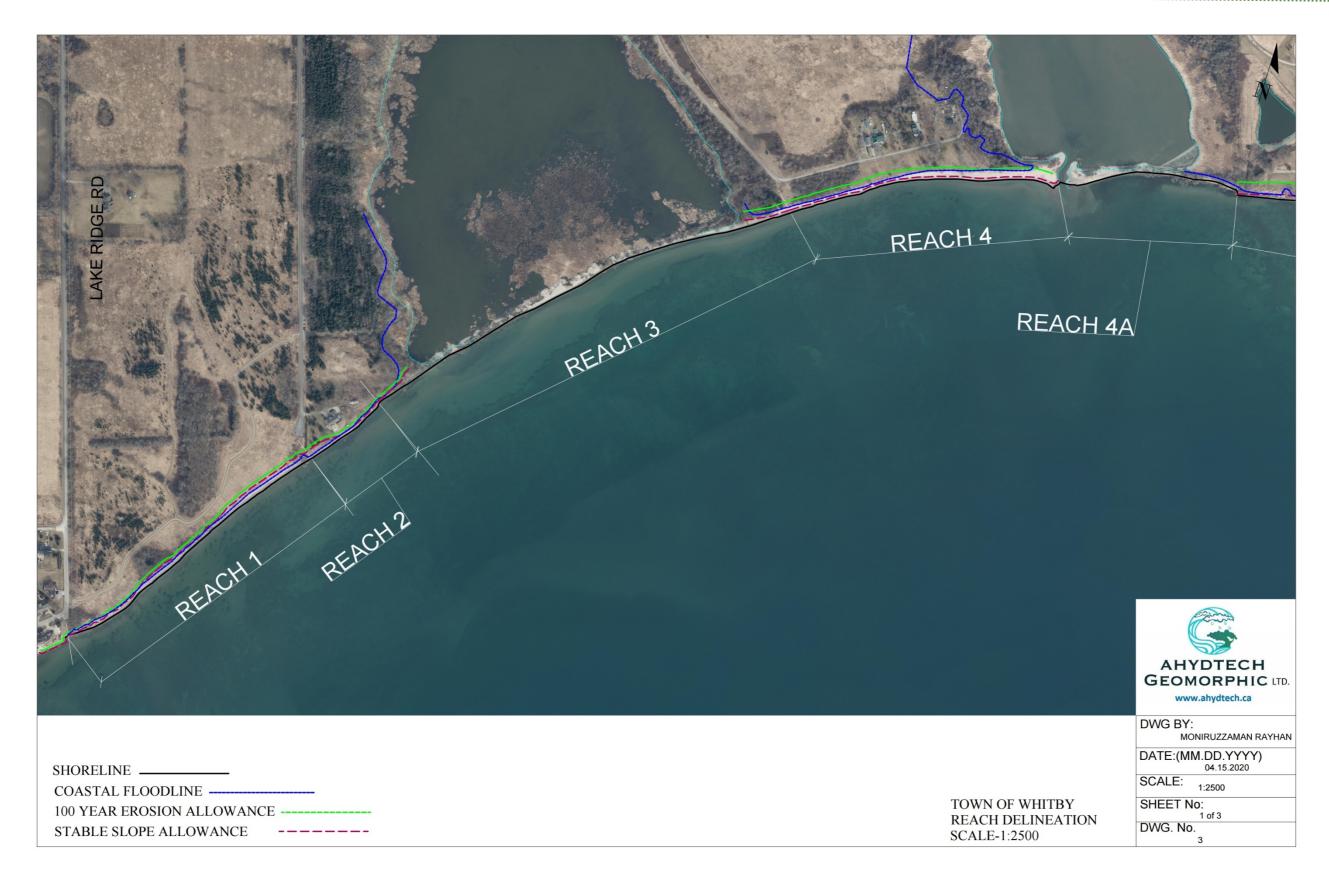
Figure S02: Hazard line for Different Reaches-1

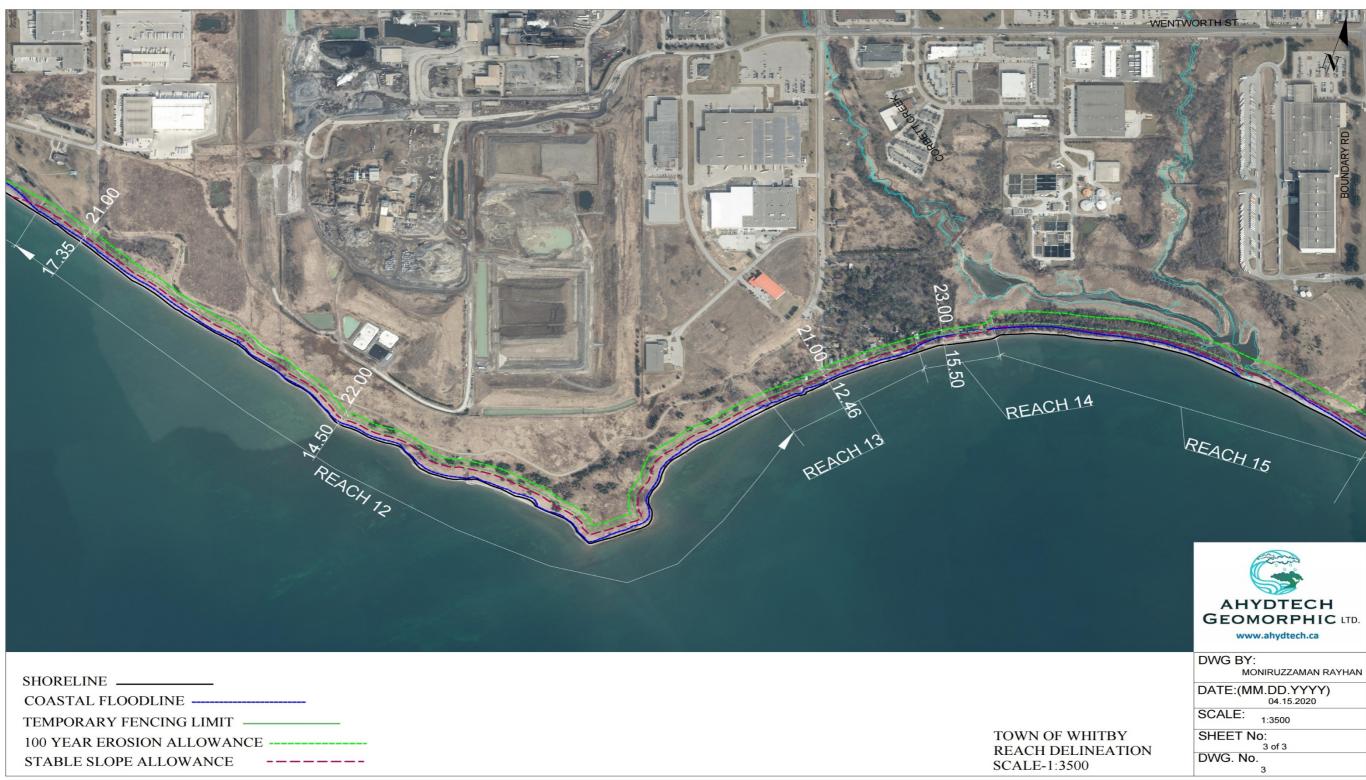
SHORELINE	
COASTAL FLOODLINE	
TEMPORARY FENCING LIMIT	
100 YEAR EROSION ALLOWANCE	TOWN OF WHITB REACH DELINEAT
STABLE SLOPE ALLOWANCE	SCALE-1:3500

Figure S04: Hazard line for Different Reaches-3

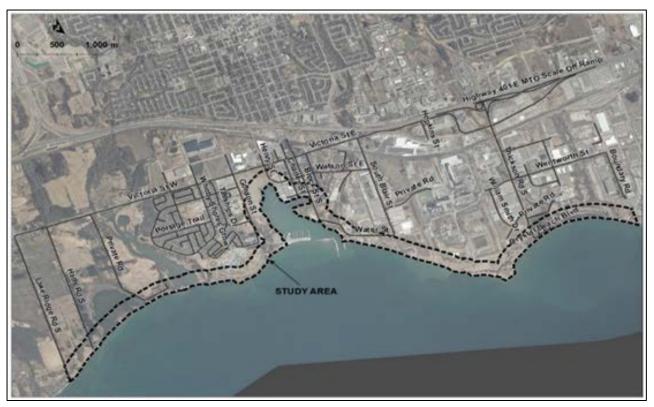
Figure 1: Study Area

Whitby shoreline is about 12 km long and extends from Lakeridge Road to Boundary Road within the Town limit (Figure 1), and consists of residential homes, boat homes, municipal roads, water sanitary storm sewer infrastructures, personal watercraft, and waterfront trail network, parkland, beach, bluff (high & low) and some sections with coastal wetland. In 2017, water levels in Lake Ontario were near the 100-year high water mark and as a result, severe erosion had been observed along Whitby's waterfront for a length of 2 km, especially from Heydenshore Pavilion to Thickson Road including some damages to Whitby Harbor structures.

AHYDTECH Geomorphic Ltd. is retained to provide Environmental Assessment of the Whitby shoreline study area (as shown in figure 1), which has been experiencing localized flooding and erosion. AHYDTECH has undertaken the Environmental Assessment (EA) process outlined by the Municipal Engineers Association (MEA), Municipal Class Environmental Assessment, October 2000 (as amended in 2007 and 2011 and 2015) approved under the Ontario Environmental Assessment Act (1990). This study has investigated the causes of the flooding and erosion, provided an evaluation of alternative solutions to the flooding issue, and finalized the preliminary design for the preferred alternative for flood remediation. AHYDTECH will prepare the preliminary design of the preferred alternative based on the ecological, coastal engineering, hydrologic, hydraulic, and flooding hazard analysis.

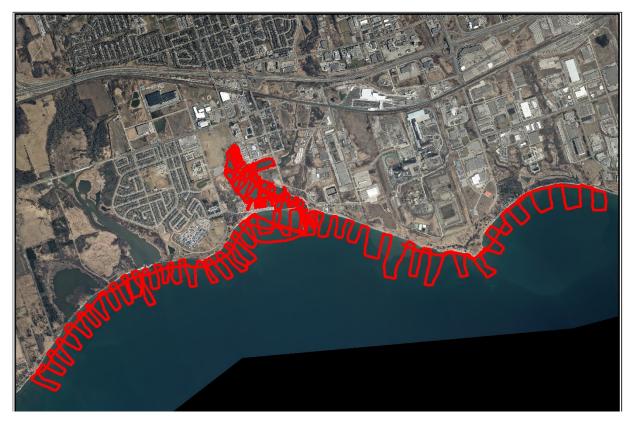
Figure 3: Bathymetry survey of Whitby near shoreline

A bathymetric survey was also conducted on April 4, April 10, April 11, April 17, June 3 and June 17, 2019 to acquire cross-shore profiles data of the lake and near the shoreline of the 12km long shoreline. The cross-shore profiles had 50m-100m interval. The survey data were taken in the lake from approximately 1m depth to 5m depth using a boat and a bathymetric survey unit. AHYDTECH has an aluminum boat which is 12ft long with a small motor. AHYDTECH has HY1500 Digital Echo Sounder and Lowrance Elite-4 CHIRP bathymetric survey units. AHYDTECH used both the survey units which were capable of recording sonar to measure depth and RTK/GPS to provide geo-referenced coordinates for bathymetric survey unit conduction. The bathymetric survey unit has capabilities to

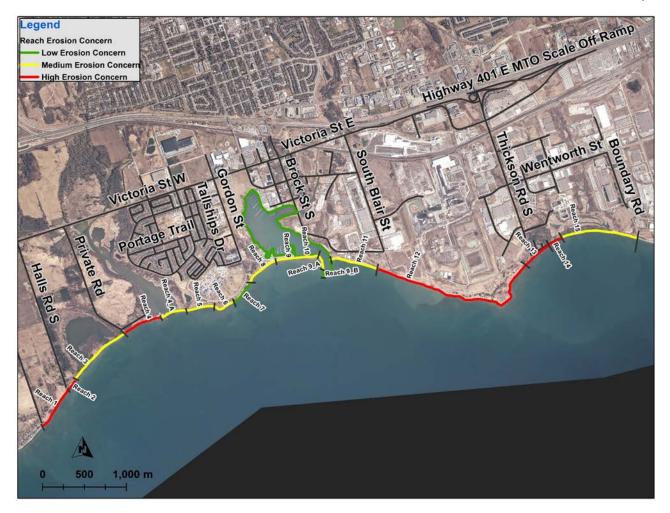
Figure 4: Reach Delineation of the Whitby Study area

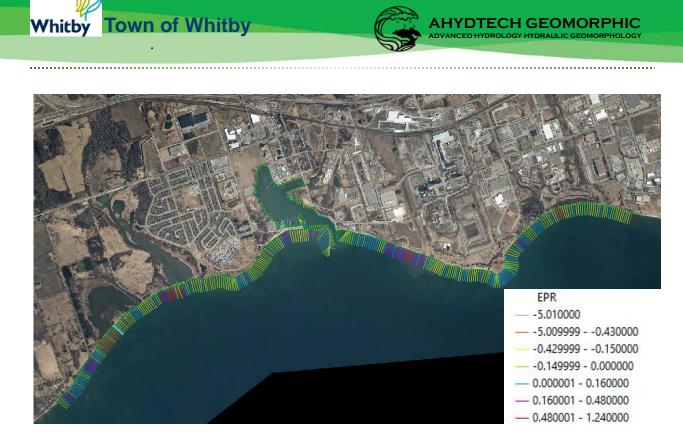
Figure 14: Rate of shoreline change (EPR m/year) along the shore from 2005-2018 (all negative signs show erosion, whereas the positive shows accretion)

The methods were End Point Rate (EPR) (Figure 14), Weighted Linear Regression (LRR) (Figure 15), and Linear Weighted Regression (WLR) (Figure 16). In DSAS work flow the EPR is calculated by dividing the distance of shoreline movement by the time elapsed between the oldest and the most recent shoreline.

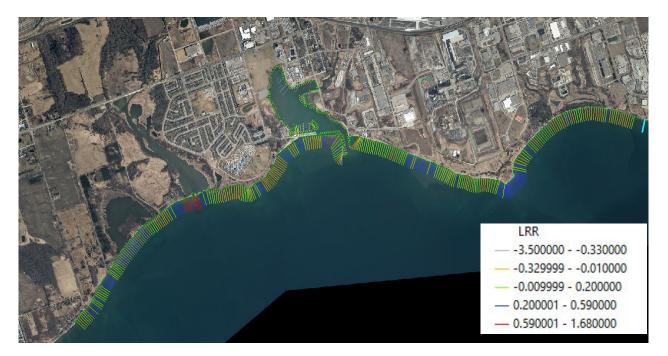
Figure 15: Rate of shoreline change (LRR m/year) along the shore from 2005-2018 (all negative signs show erosion, whereas the positive shows accretion)

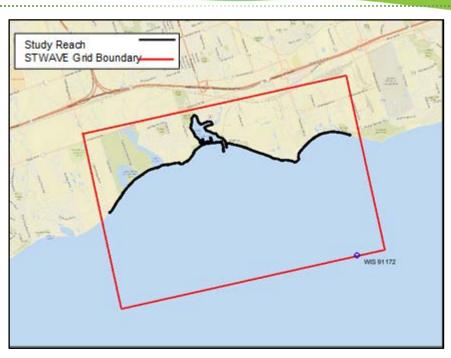
Figure 24: Domain of STWAVE Model

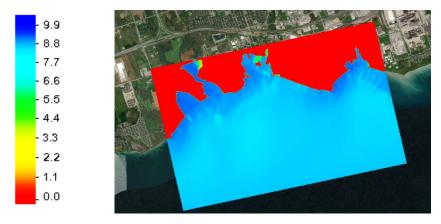
Figure 26: Wave Period in the model domain for 100-Year Return Period Condition

Typical wave period for the study area was found within 8-10s which is represented in Figure 26. Values of wave period for the entire study area in different return period cases are provided in Appendix F.

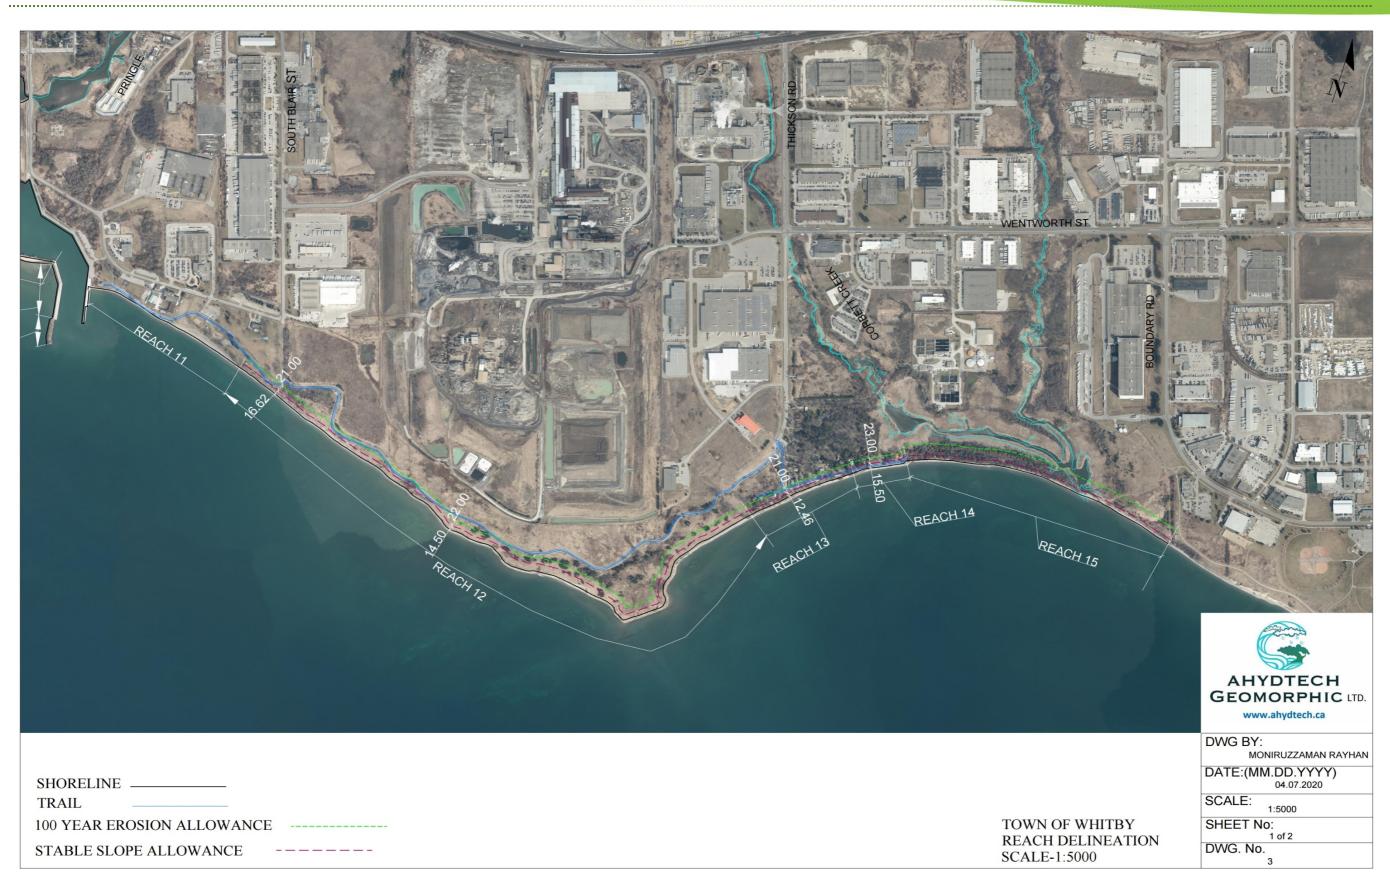
Figure 35:100-year erosion allowance obtained from slope stability analysis and recession analysis

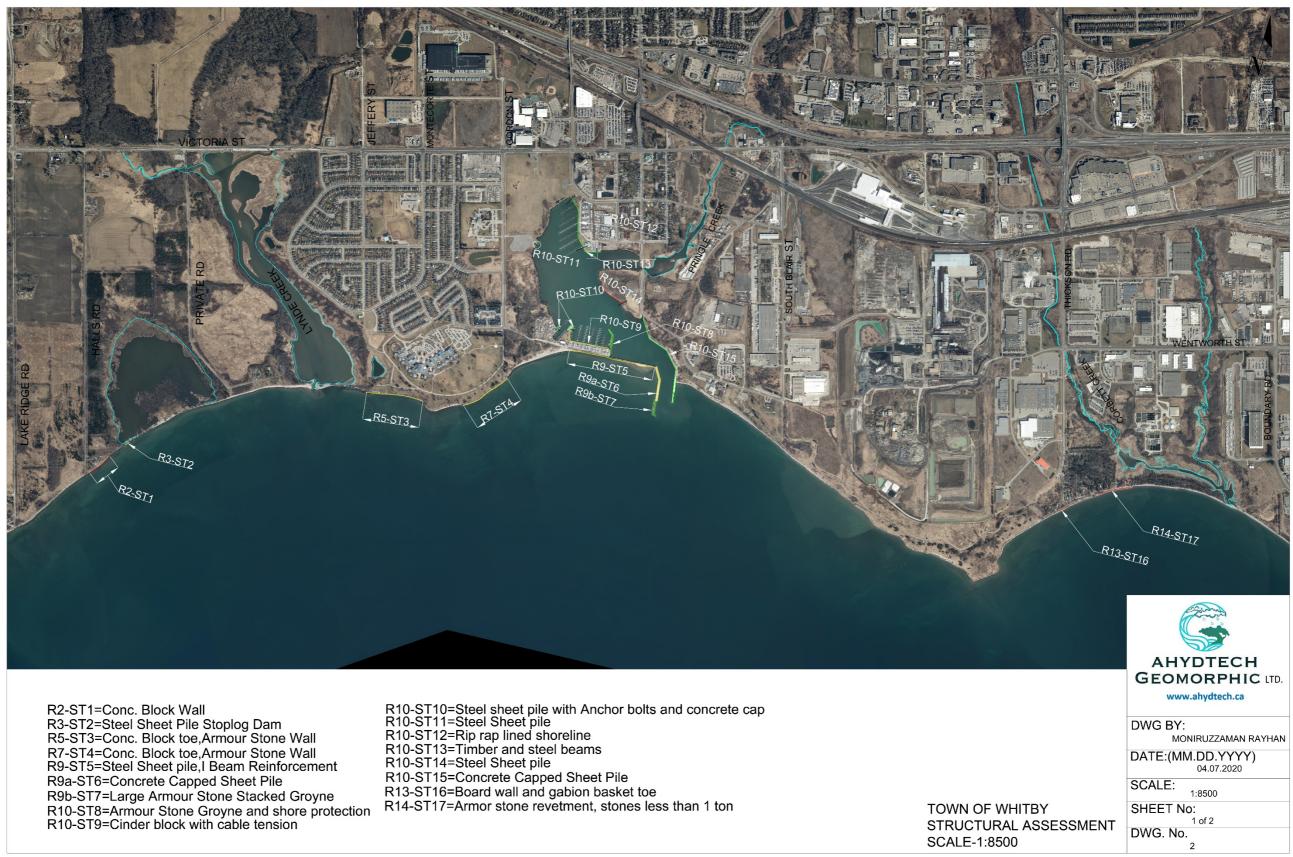
Figure 36: Identification and breakdown of reaches based on structure type

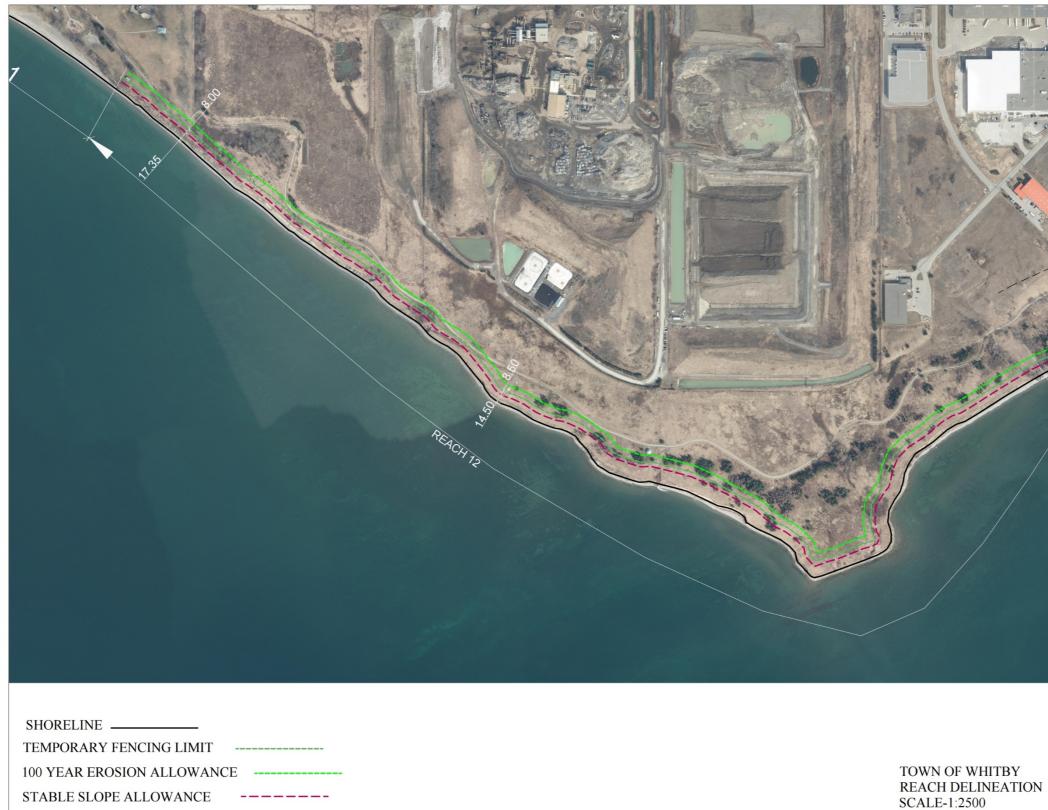
Figure 37: Erosion hazard limit at Reach 12.
